Solar Cell Degradation during the 26-kW Electric Propulsion Space Experiment

(ESEX) Flight

J.H. Schilling*, G.G. Spanjers†, D.R. Bromaghim‡

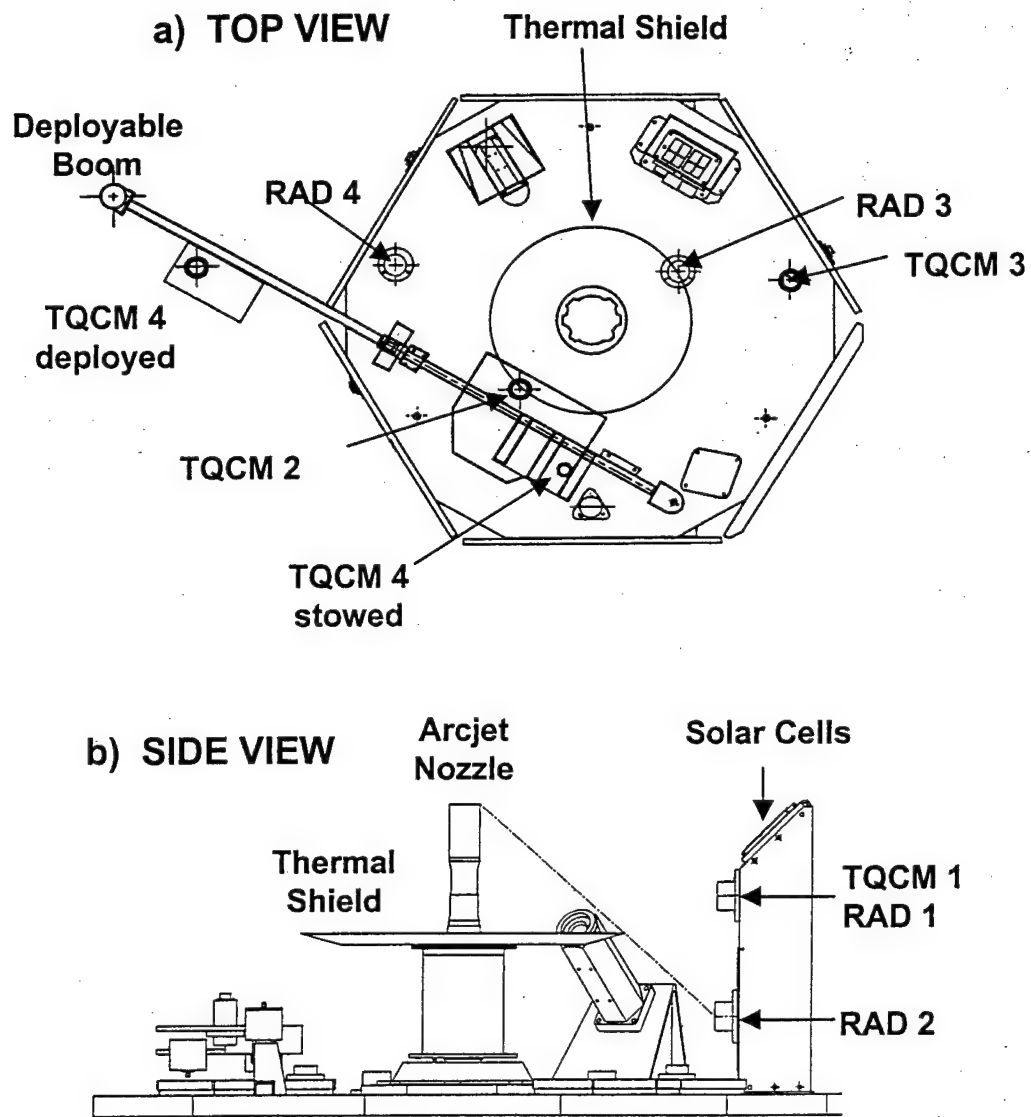
Fig. 1 (a) Top view and (b) Side view of ESEX showing the locations of the contamination sensors.

The ESEX flight unit is equipped with 4 microbalances, 4 Radiometers, and 2 sections of GaAs solar array cells. The sensors are positioned on the ESEX flight unit as shown in Fig. 1. The solar array cells are positioned 43 cm from the arcjet exhaust plane, 3 degrees from horizontal, relative to the thruster exit plane and downstream of the exhaust, and with a sensor angle of 42 degrees if the sensor normal relative to the thruster exit.

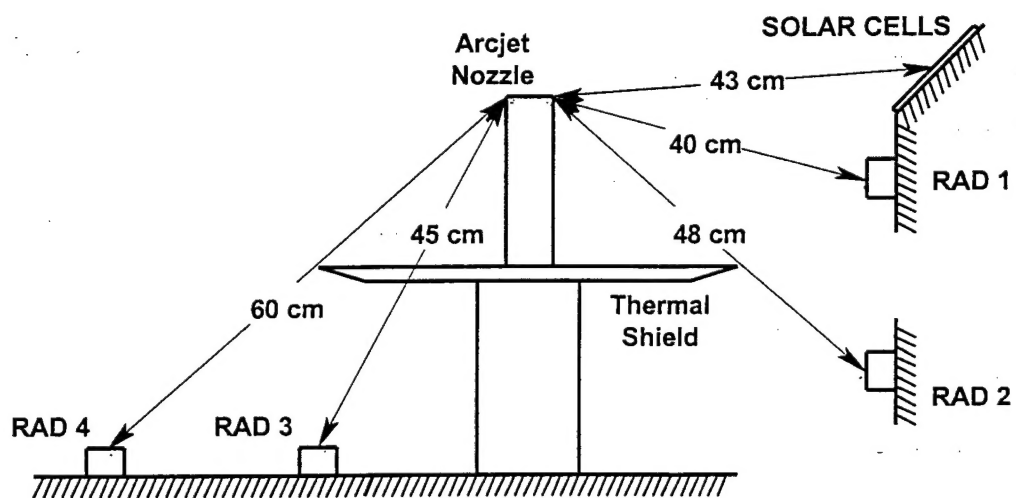
Fig. 2 Locations of the solar cell segments relative to the arcjet nozzle.

Possible effects of arcjet operation on solar array performance is a matter of understandable concern. To address this issue, two small solar array segments are mounted on top of the ESEX diagnostic tower as shown in Fig. 2. Each segment consists of four 2-cm by 4-cm gallium arsenide cells in series, with each cell under a .006-inch thick cerium-doped borosilicate cover glass. This cover glass overhangs the edge of the cells by 0.2 mm, but the interconnects between

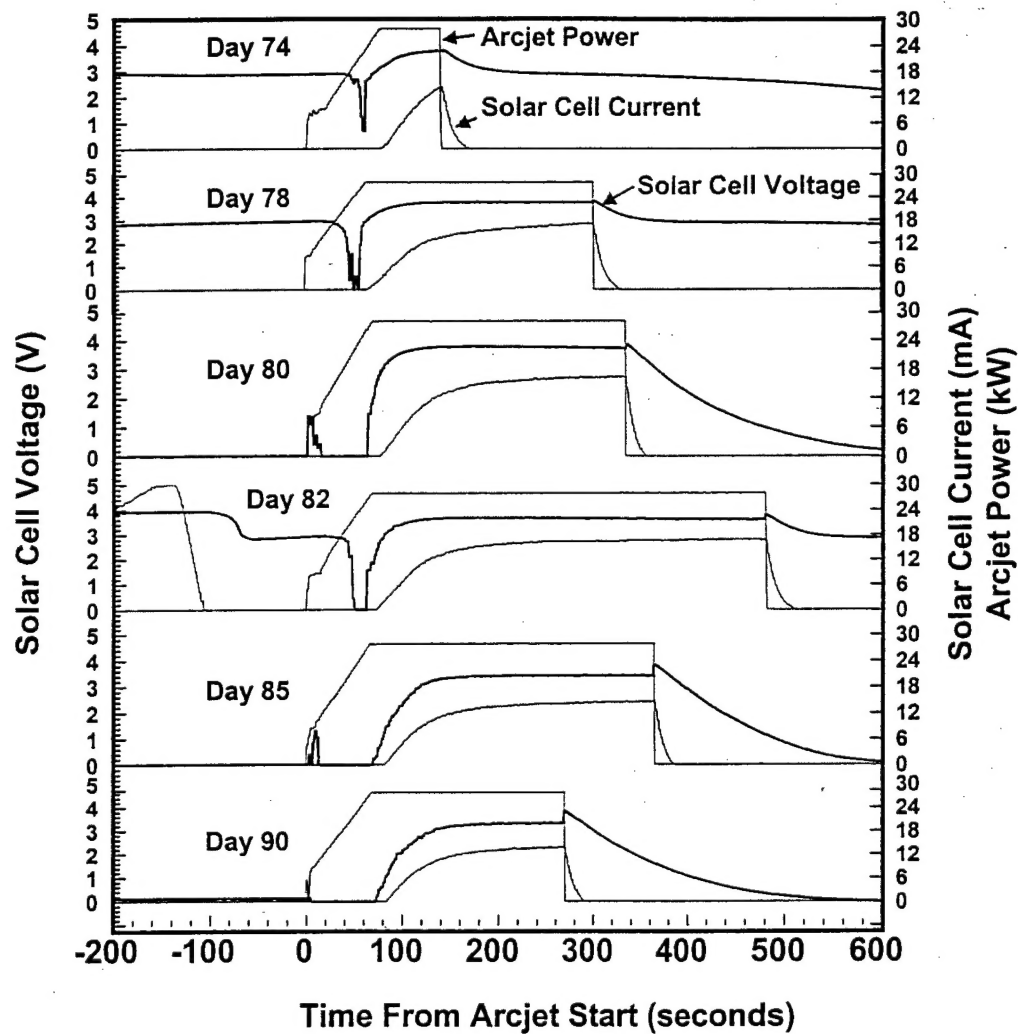
Fig. 3 Solar cell response to the ^{six} primary ESEX arcjet firings. *e*

Figure 4 shows the solar cell voltage and current during the six primary arcjet firings. The current rises above zero about two minutes after arcjet start, reaching a nearly constant value in an additional two minutes, and dropping rapidly to zero after arcjet shutdown. This is consistent with illumination of the solar cells by the glowing arcjet body. Solar cell voltage also follows the same general pattern during the three firings which occurred during eclipse (on days 80, 85, and

90), with the voltage rise occurring slightly earlier, and the post-shutdown drop-off substantially slower, than is observed for the current. Although not apparent in the scale used in (Fig. 4) voltage is also observed to drop off very slightly during the near-equilibrium phase of the longer firings, which is expected as the solar cell temperatures increase.

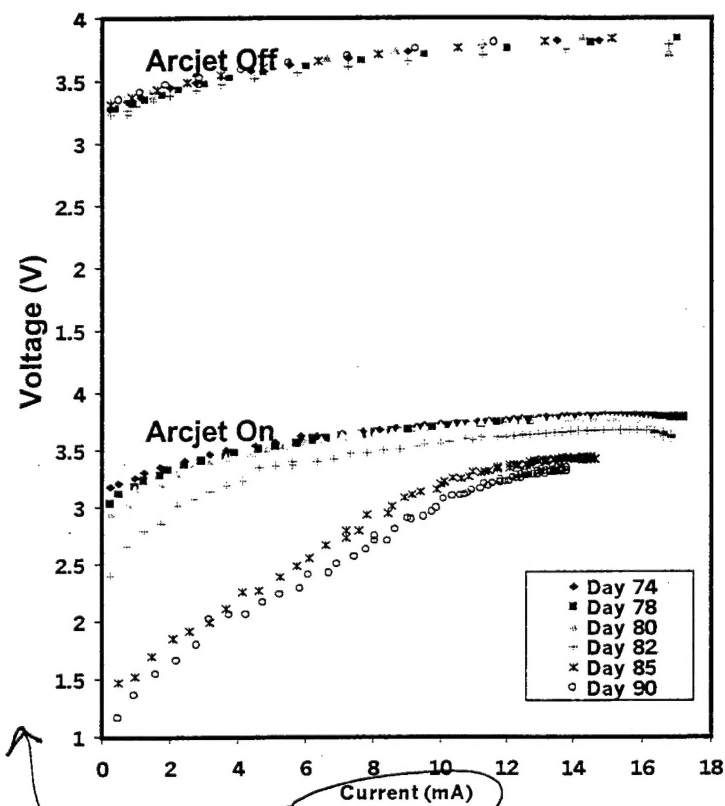
Fig. 4 Solar cell ^{six} I-V curves during the ^{six} ESEX arcjet firings.

Please make consistent w/ title for Fig 4, pg 11.
In light of the observed effect of arcjet operation on solar cell voltage, it may be instructive to examine the (V-I) curve for the solar cells with the arcjet in both on and off states. The illumination of the solar cells by the incandescent arcjet body, which continues for some time following arcjet shutdown, offers an opportunity for such a comparison ^o and Figure (5) shows voltage (vs.) current data for all six full-length arcjet firings. With the arcjet shut down, the data falls on a single curve, and even very small currents correlate with open-circuit voltages in excess of 3 volts. When the arcjet is operating, however, the (V-I) curve is shifted down in voltage from the arcjet-off case, with the magnitude increasing at each firing. The shift is most pronounced for low current values, and much less significant at currents of 10 mA or greater. This is consistent with the observed voltage jump following arcjet cutoff, and may help explain the voltage drop at ~~sixty~~ ⁶⁰ seconds after ignition in the partial-illumination cases. 4 ?

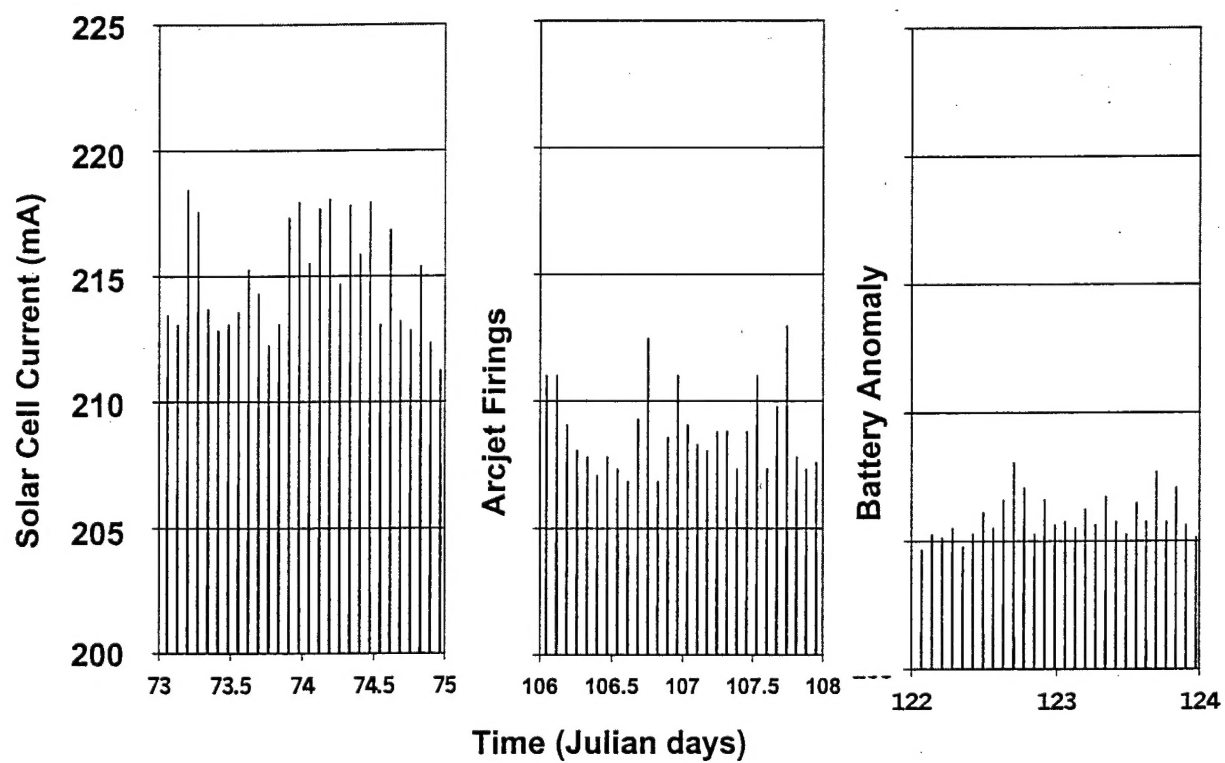
Fig. 5 Solar cell current at selected times during the ESEX flight.

5 ?
Long-term degradation of the solar cells is shown in Fig. (6) where the solar cell current is plotted over several days at three sample times during the flight; before the arcjet is fired, after the arcjet ^{is} firings, and after the battery anomaly. Prior to the arcjet firings a solar cell current of about 214 mA is observed. After the eight firings the current drops to about 207 mA. Following the battery anomaly a smaller decrease to about 205 mA is observed. This indicates that during the arcjet firings a 3% decrease in solar cell current and power occurs. The source of this decrease is likely a decrease in the solar transmissivity of the solar cell cover glass. No degradation of the main ARGOS arrays was reported as a result of the ESEX arcjet firings.
